Report No. CG-D-98-76

DEVELOPMENT, TEST AND EVALUATION OF AN
EXPLOSIVE EMBEDMENT ANCHOR FOR USE IN THE
MOORING OF SMALL COAST GUARD BUOYS

June 1976

Final Report

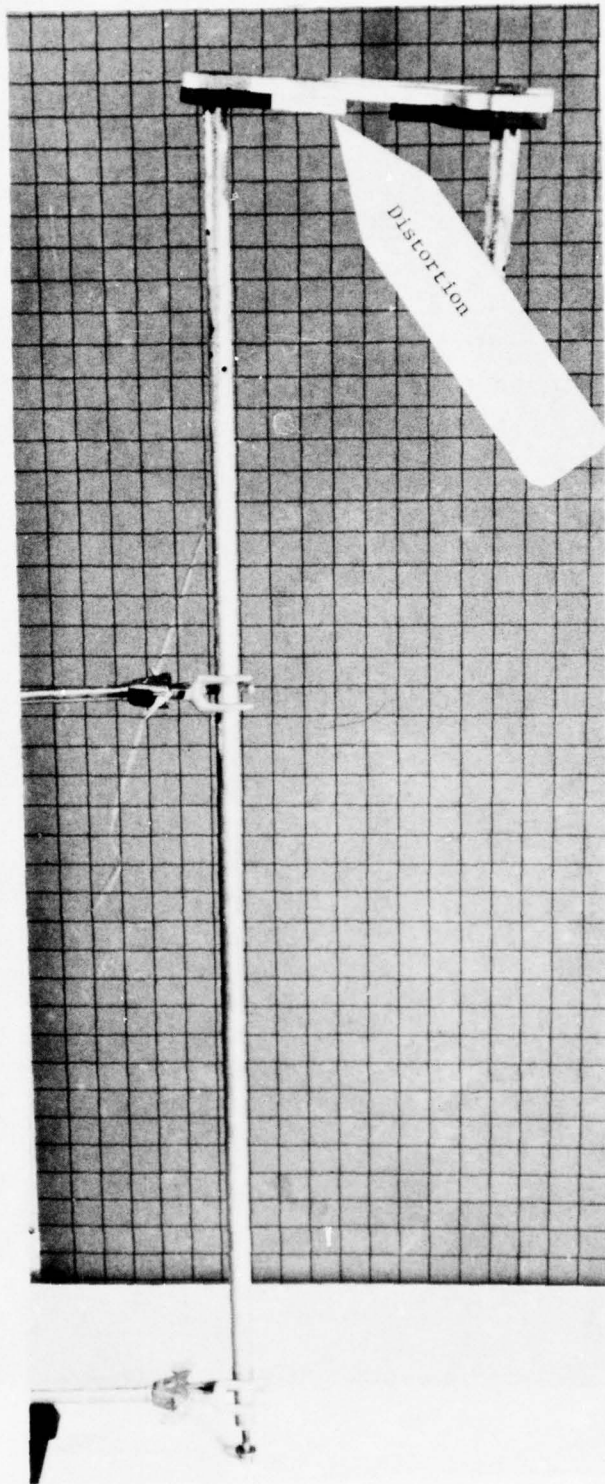
Figure 13. Trigger plate distortion.

A number of situations occurred where the gun did not fire after deployment. These malfunctions can be described in two separate cases. In the first case, after following the prescribed safety features, the unit was brought back to the surface and held there to inspect it for the probable cause of malfunction. It was noted that the firing mechanism hydrostatic lock had functioned in that the trigger arm had been displaced partially by the normal upward movement of the trigger plate. This represented a condition where the constraint provided by the firing mechanism hydrostatic lock had been removed by normal functioning of that lock but where the trigger had been displaced only partially and was in a balanced position where slight additional movement would cause the cocked spring to release and actuate the firing pin. Inspection also showed that the redundant hydrostatic lock (mounted on gunstand) was in place. (See Figure 9a.) A boat pole was used to carefully push the trigger arm down to the pre-displaced position prior to bringing the gunstand on board. Further inspection on board revealed that distortion had occurred between the trigger plate and the firing leg (Figure 13) which moves the trigger plate against the trigger arm of the firing mechanism. The trigger plate itself was found to be distorted when a straightedge was laid across its flat surface.

It was obvious from the inspection that the repeated acceleration loadings of the trigger plate during firings had weakened the base material to the point where distortion had taken place. This distortion in turn was the cause for the malfunction and was later corrected; however, it was found that the condition would continue to recur after one or two additional firings.

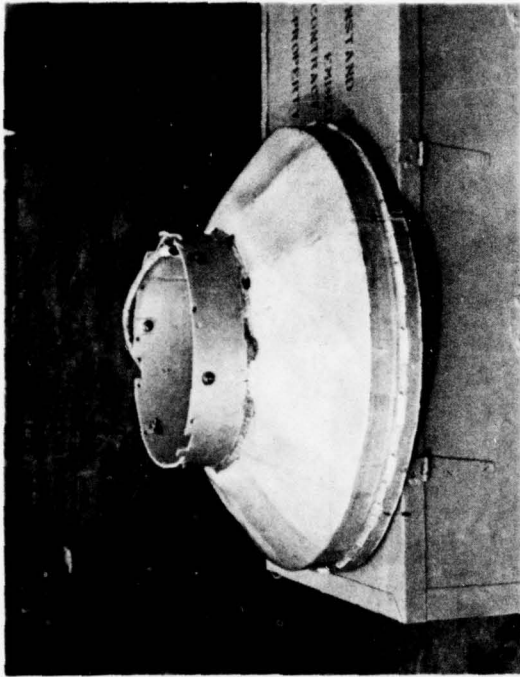
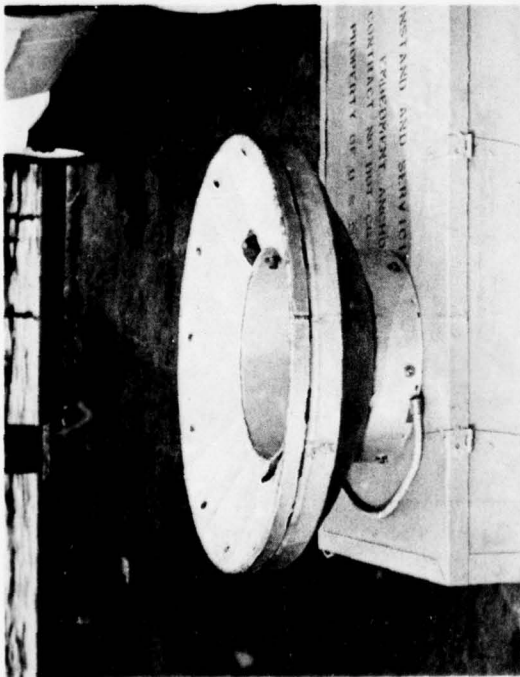
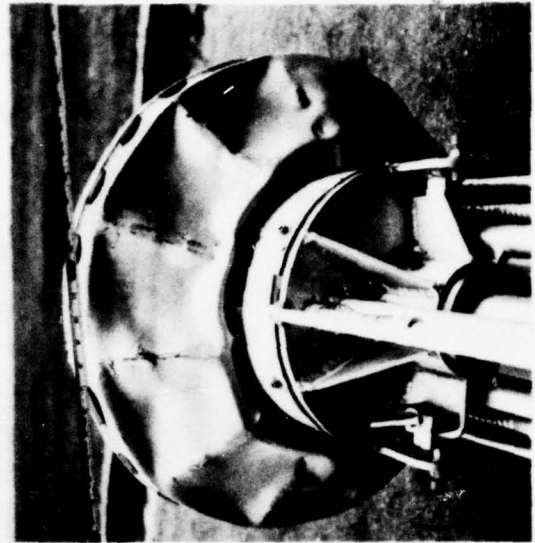
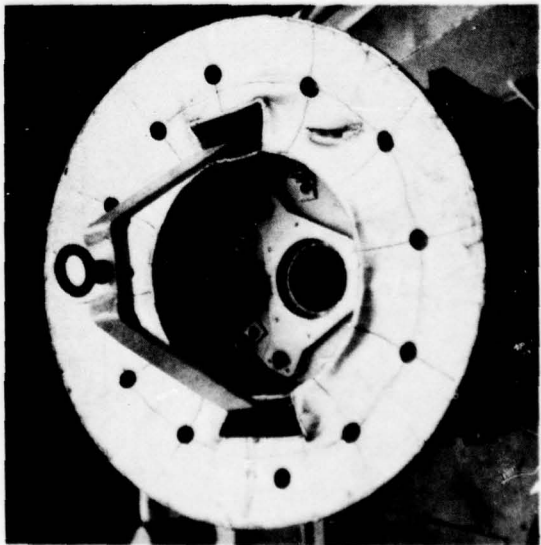
Figure 14. Reaction cone damage.

One other problem involved the reaction cone. The thin aluminum cover began to tear at the corner of an opening for the lifting handle. The polyurethane foam in the chamber adjacent to this tear began to crumble. The firings were completed using the torn cone. The cone was replaced with 1/16-inch sheet aluminum stock and a less rigid foam than that previously used (Figure 14). Buckling continued to occur, and a rigid, non-foam-filled reaction cone was successfully developed and used as a replacement (Figure 15).

↙ 10 firings ↘

↙ 35 firings ↘

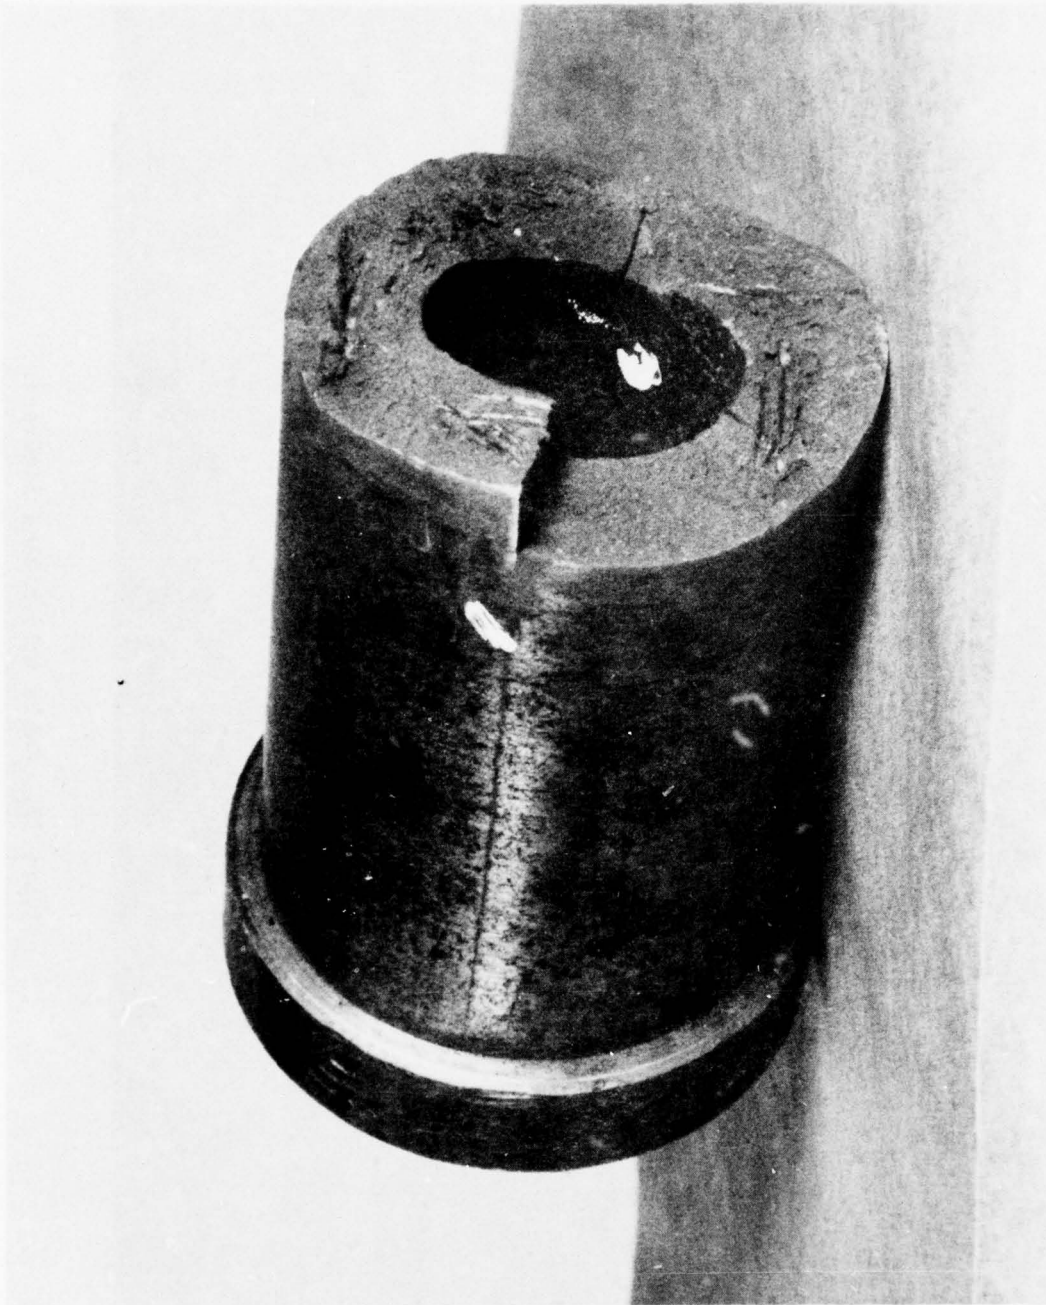
Figure 16. Failed gun barrel.

One gun barrel failed toward the end of the Long Island Sound testing (Figure 16). It is estimated that the total number of firings with this barrel was approximately 100 (the Contractor's recommended replacement life of the barrel).

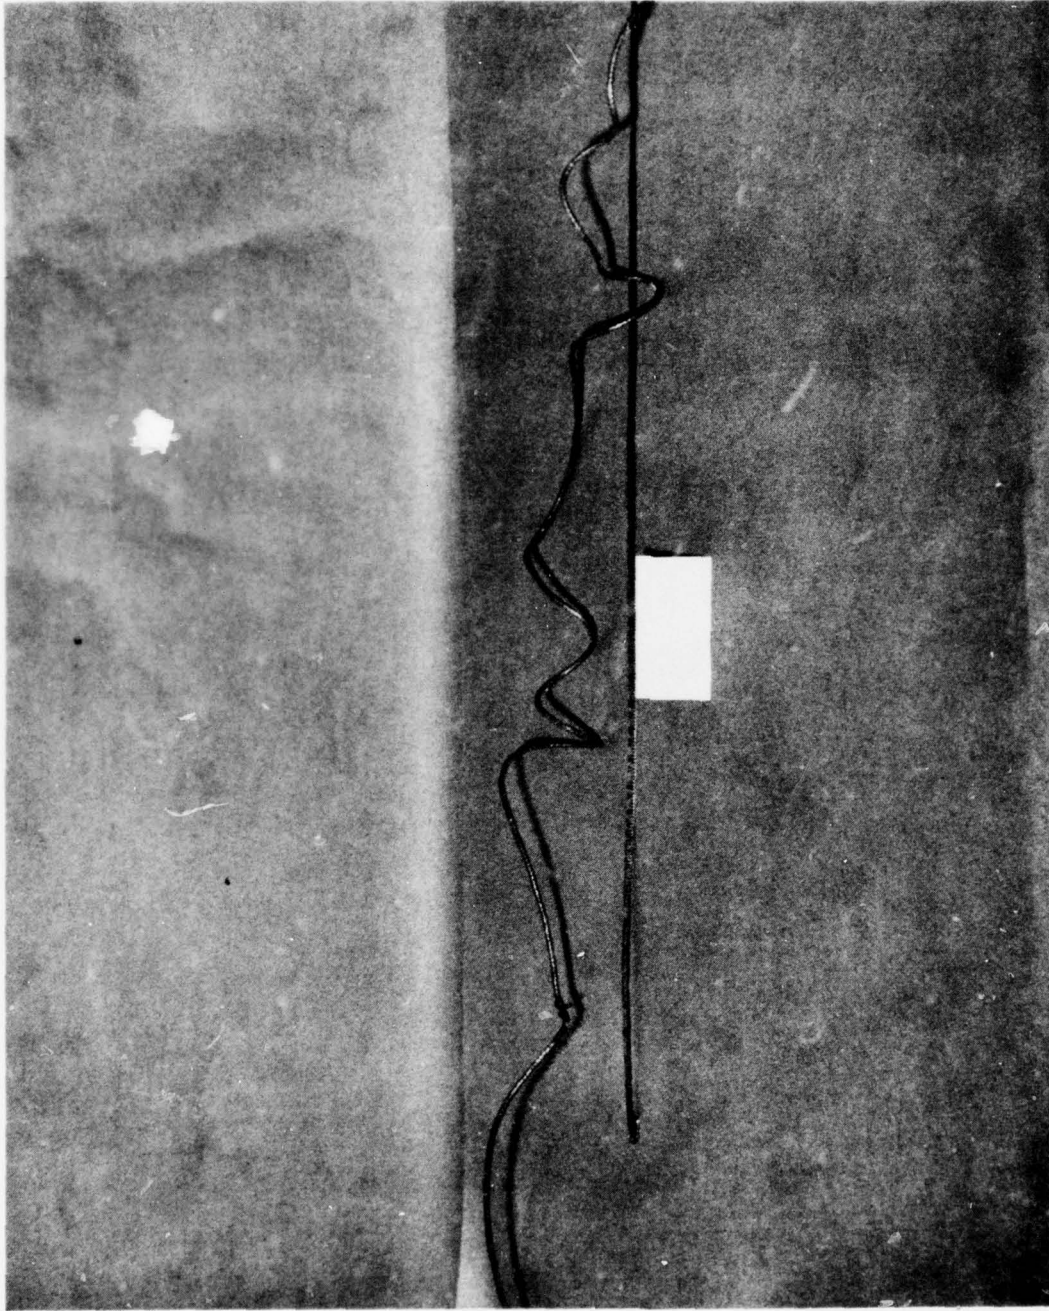
Figure 17. Cable 1x19 kinked figure-8.

The examination of those cables recovered showed two groups of failures, each of which showed cable kinking. (See Figures 17 and 18.)

The first five failures occurred 39 to 50 days after deployment of buoys. Three of these buoys were recovered, and examination showed the failure in two cases to be in the area where the cable was attached to a cleat while the buoy was being attached to the cable prior to launching. The combination of small cleat radius and stress placed on the cable by the boat mooring load put permanent kinks in the cable. Four additional cable failures appeared to result from the same cause, although much less severe, as indicated by longer time to failure. To preclude further cable damage in future deployments, the cleat was replaced by a bollard with an 8 1/2-inch diameter (39 times the cable diameter).

The second group of failures occurred on buoys deployed after the bollard was installed. This type of failure occurred primarily within 15 feet of the anchor. Sample failed cables sent to the manufacturer revealed failure of up to 12 strands of the 19 total strands to have occurred in the torsional fatigue mode. Thus, it was concluded that the natural torsional unlaying of the cable from hockling during the firing process, succeeded by repeated buoy loadings, was causing the cable to fail in an area where it previously had kinked. This area primarily is in that portion embedded in the bottom or just above it.

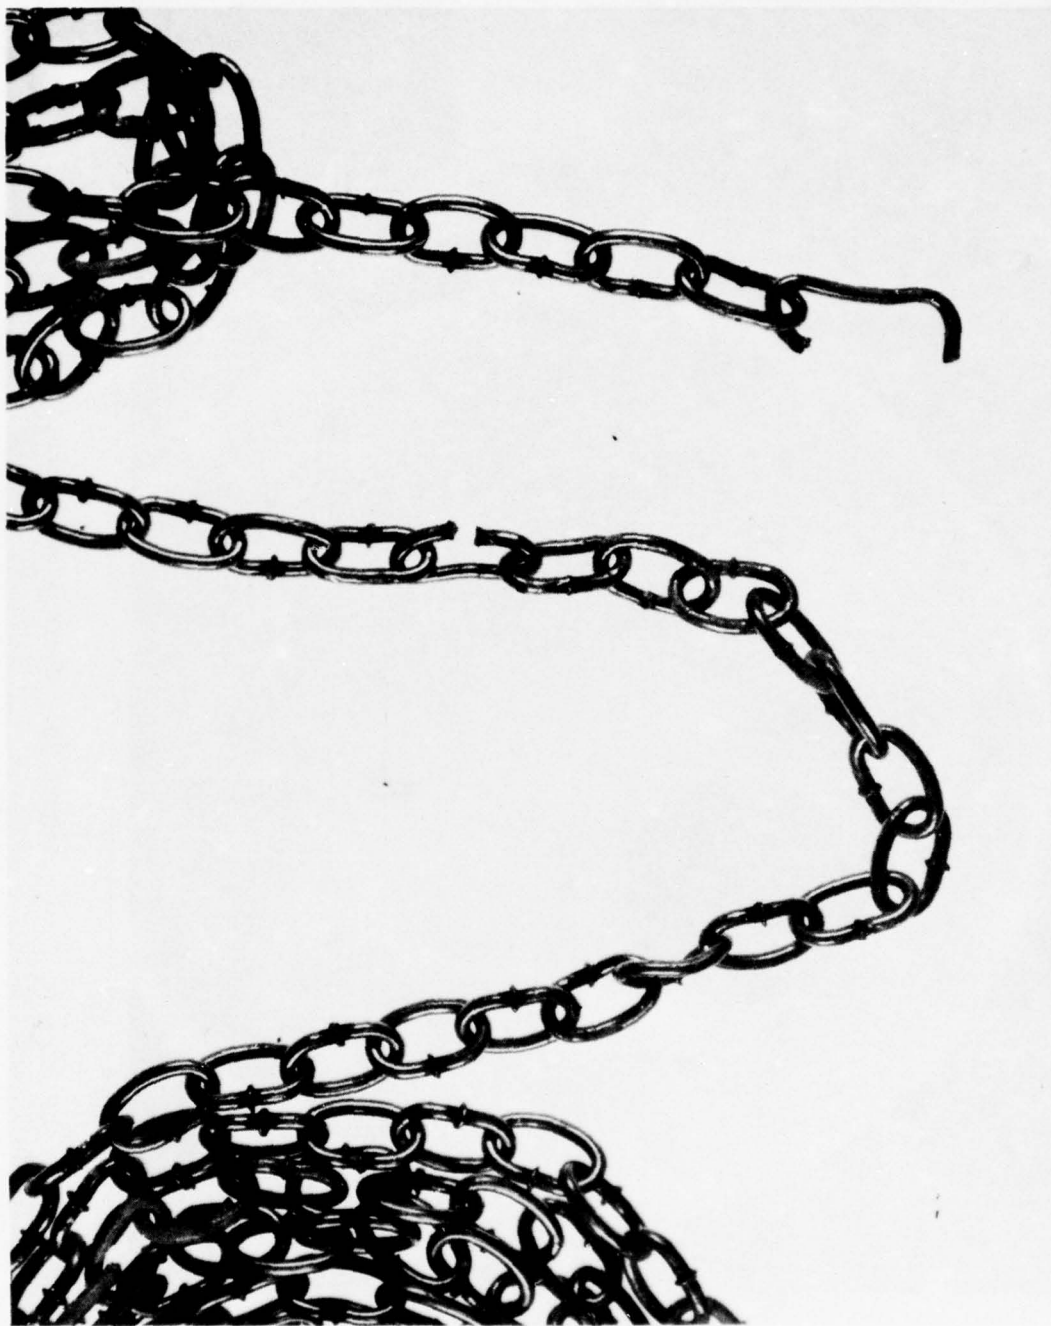
Two types of chain were evaluated at this time. These were 1/8-inch proof coil #316 stainless steel and #4 straight link proof coil galvanized machine chain. The chain was coiled in the aluminum cans and held in place by #20 soft copper wire at six equi-distant points. (See Figure 25.) Several test firings were made of each type. A short "pigtail" of cable was attached to an anchor without flukes for easy recovery. These tests were successful with only a slight elongation of links on the stainless steel chain and one bent thimble on the galvanized steel chain. Several attempts to set buoys with the stainless steel chain met with failure due to parted links or the "pigtail" from the anchor parting (Figure 26). The galvanized #4 straight link proof coil machine chain (Figure 27) was used with partial success. One buoy was set, and in other attempts the "pigtail" failed as in the case with the stainless steel chain.

Figure 26. Stainless steel chain showing elongated links after firing.

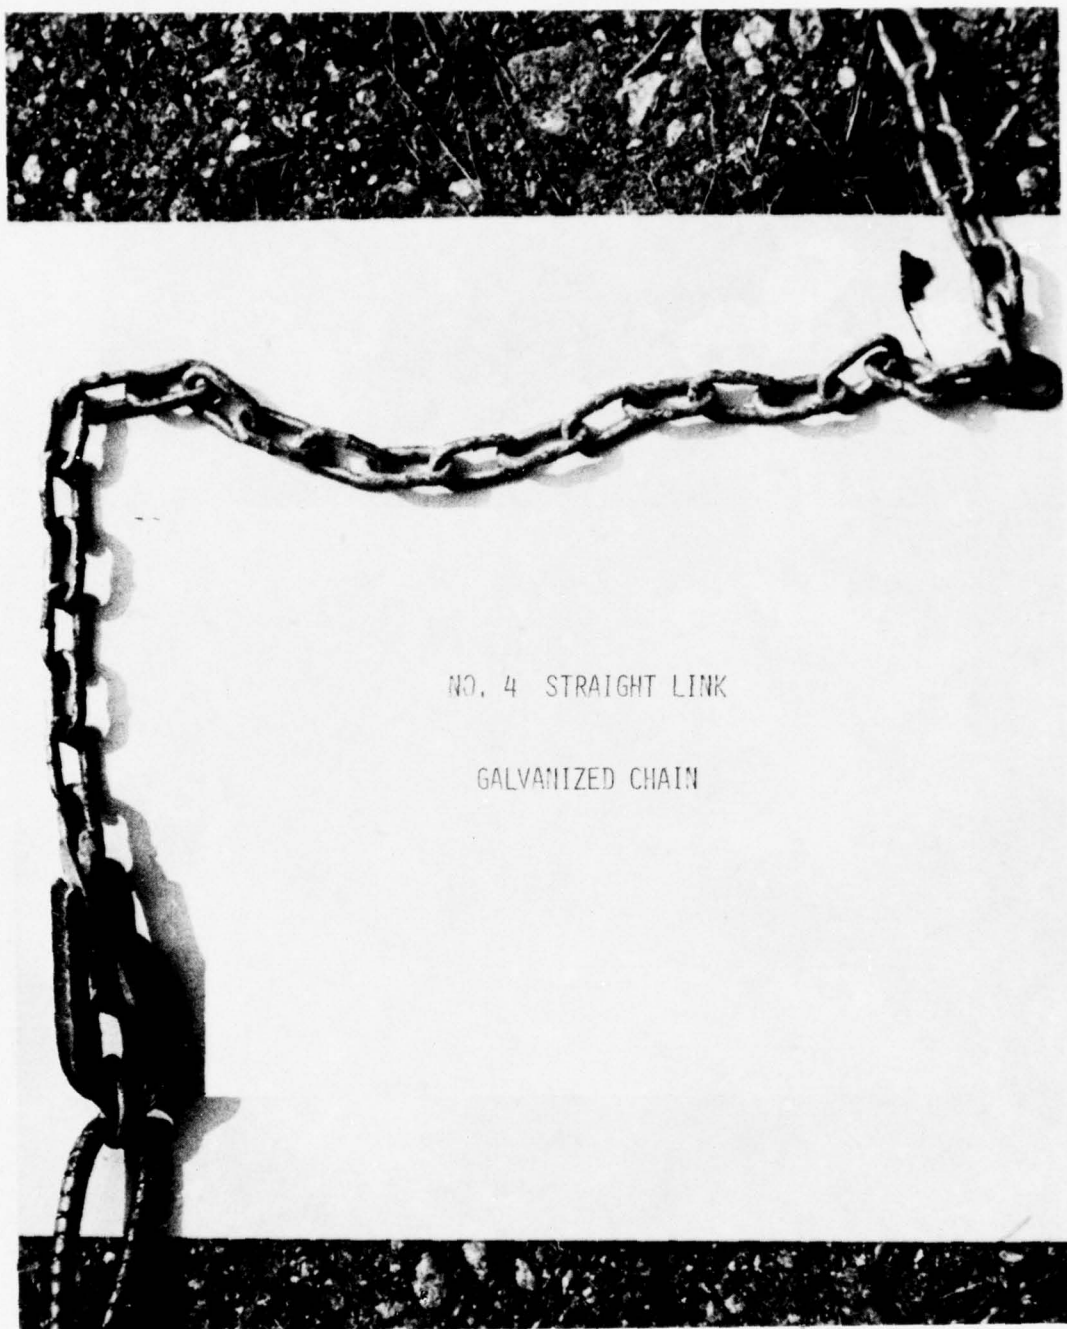
Figure 27. Galvanized No. 4 chain - failed links.

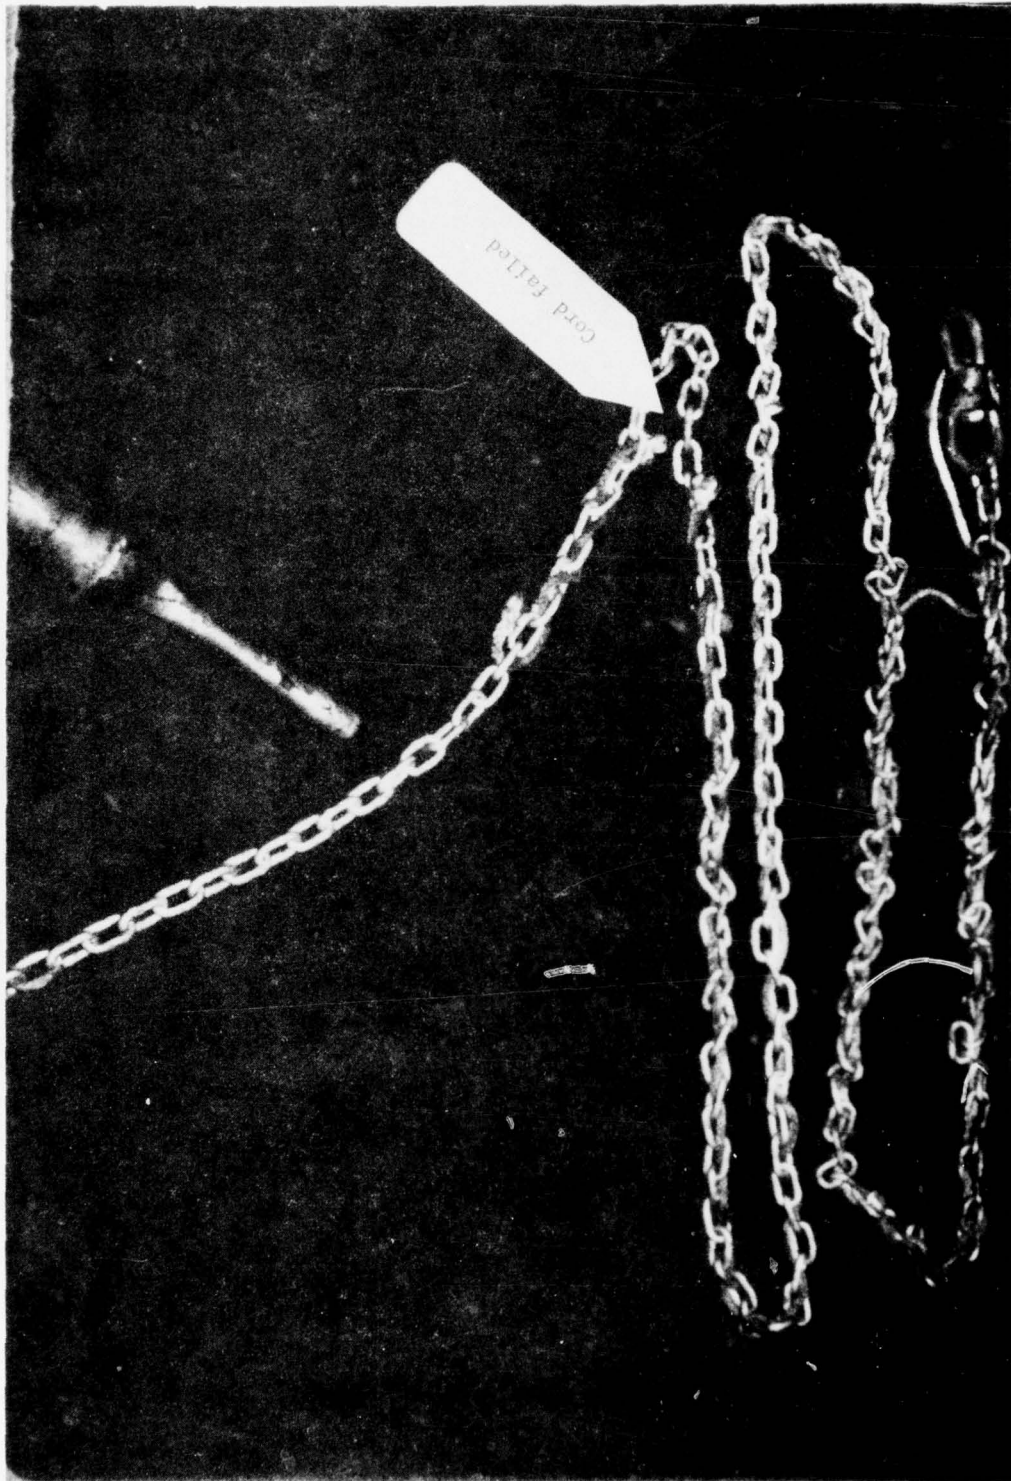
Figure 29. Chain mooring with "shock cord" (after firing).

Attempts were then made to reduce the impact loading on the chain links which was causing them to fail. Two different concepts were used to achieve this. In one case, a small diameter nylon cord (3/16 to 1/4 inch) was rove through the individual chain links and secured at each end of the chain (Figure 28). The length of cord used (10 ft.) was less than the length of chain it was used on (12 ft.). The effect of this cord was to provide a "spring" in the chain as well as provide a cushion between the individual links, thus reducing the link-to-link impact loads by absorbing energy in elongation of the nylon cord. This method was generally found to be successful in that the cords elongated and parted in some cases (Figure 29) resulting in reduced incidence of chain elongation and failure.
